IN-DEPTH CATHODIC PROTECTION  
SYSTEM INSPECTION AND RECOMMENDATIONS

MAY 2006

LACEY V. MURROW BRIDGE (90/25S)  
HOMER HADLEY BRIDGE (90/25N)

PREPARED BY:  
HARDESTY & HANOVER, LLP • CONSULTING ENGINEERS  
NEW YORK, NEW YORK  
&  
CONCORR, INC.  
STERLING, VIRGINIA

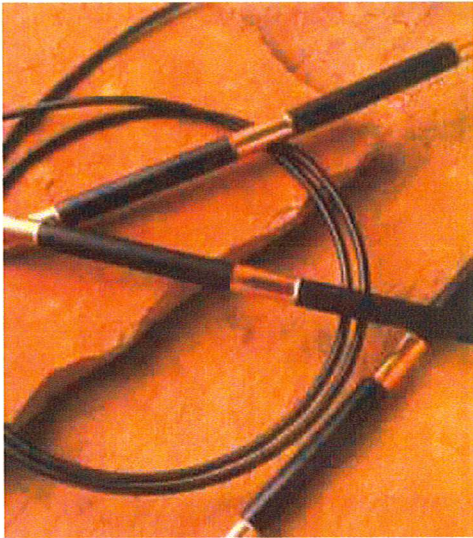
Figure A-2: Titanium Anode

The mixed-metal oxide titanium (titanium) anodes were installed as replacements to the PT anodes based on recommendations provided by this team after the 2004 inspection of the cathodic protection systems. The titanium anodes were selected as they offered a service life in excess of 20 years. In addition, the length of the titanium anodes required to provide equivalent current compared to the PT anodes would be significantly lower. The shorter length of 3 feet 3 inches (1 meter) is much more convenient to handle compared to the 30 to 80 feet length of the PT anodes. The much smaller diameter (0.125 inches) and the longer length of the PT anodes made them susceptible to kinks and damage. The titanium anodes are more robust and approximately 1 inch in diameter. In addition, the connection between the copper wire and the titanium anode is made using a special process that results in a connection which is much more robust than that used in the PT anodes. These connections are not considered to be prone to the kind of failures experienced by the PT anode endcaps. This anode assembly is comprised of a copper wire to supply the impressed current, the anode, and a weight to hold the anode down. The titanium anodes are positioned a few feet below the bottom of the pontoons. The titanium anode is 1 m in length and has three crimp points. The insulated copper wire passes through the hollow section of the anode. The crimps at the top and the bottom of the anode provide a watertight seal and the crimp in the middle provides an electrical connection to between the copper wire and the titanium anode. At each crimp point a copper sleeve is installed. The copper sleeve is required for the crimping process and is designed to corrode with the application of cathodic protection current and is expected to dissolve away. Figure A-2 in Appendix A presents various photographs of the titanium anodes. These photographs show the anode, the copper sleeve corroding upon application of current, and the anode after the copper sleeve has completely dissolved.

New Titanium Anode

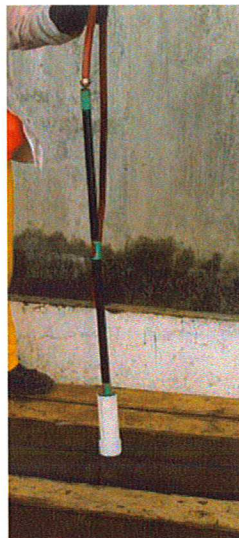
Copper Sleeve  
Corrosion

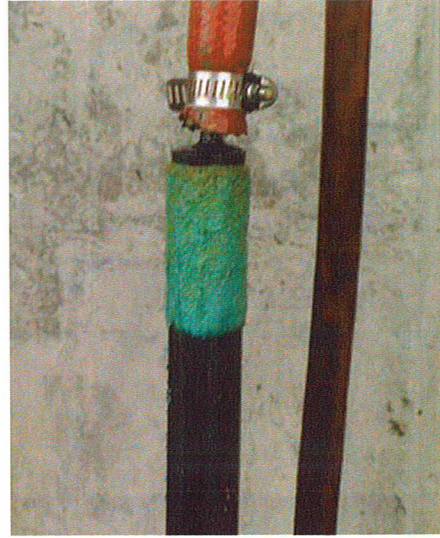
Close up of Copper Sleeve Corrosion

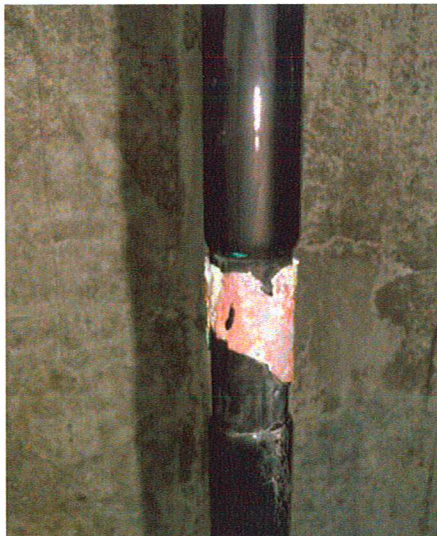
Partially Corroded Sleeve

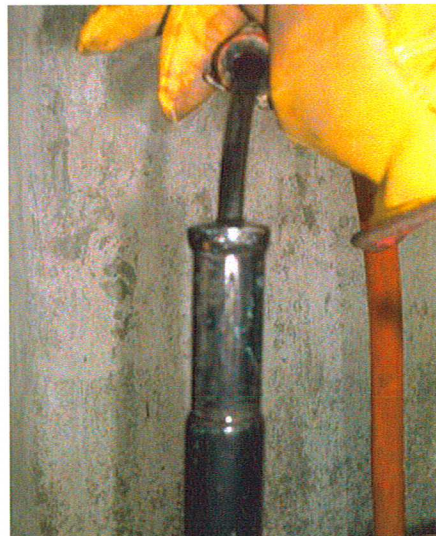
Completely Corroded Sleeve

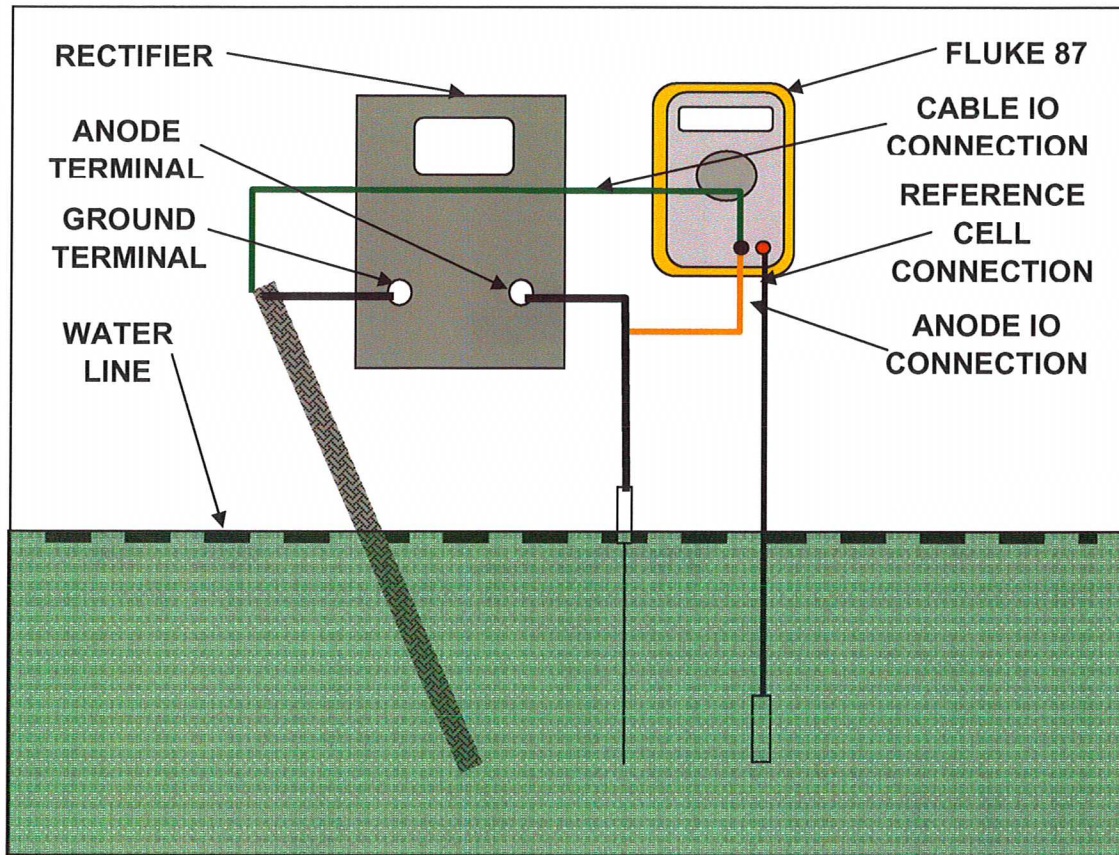
Figure A-3: Potential Measurement Setup

The anode and cable potentials were measured using a portable silver-silver chloride reference cell designed for use in a marine environment. The reference cell was submerged in the water and it was connected to the negative terminal of the multimeter. The positive terminal of the multimeter was connected to either the positive (i.e. anode) or the negative (i.e. cable) terminal of the rectifier (see Figure A-3 in Appendix A). The “instant-off” potential was measured when the rectifier current output went to zero. As the rectifier output is not filtered, the “off” potential of the anode and anchor cables can be obtained by measuring the minimum and maximum peak of the waveform, respectively. The peaks of the waveforms can be measured by using the min-max function of the multimeter. However, presence of noise makes it difficult to obtain accurate peak measurements. Therefore, the instant-off potentials were measured by manually powering down the rectifier for 1 second.

One of the challenges that had to be overcome during the inspection was to submerge the reference cell in the water and simultaneously connect to the cable or the anode wire in the rectifier. On the LVM Bridge, this was accomplished by dropping the reference cell in the water adjacent to the access hatch located on the north side and routing the reference cell cable to the rectifier through the hatch. On the HH Bridge the reference

cell was routed through the north cable port in each pontoon to the outside and then dropped in water. This process was developed during the last inspection and the access points created were left in place for use in future. It should be noted that placing the reference cell in this fashion makes it susceptible to picking up interference from adjacent systems and it measures an average of all the elements present in the vicinity of the reference cell. In ideal conditions, the reference cell would be placed very close to the cable or the anode whose potential is to be measured.

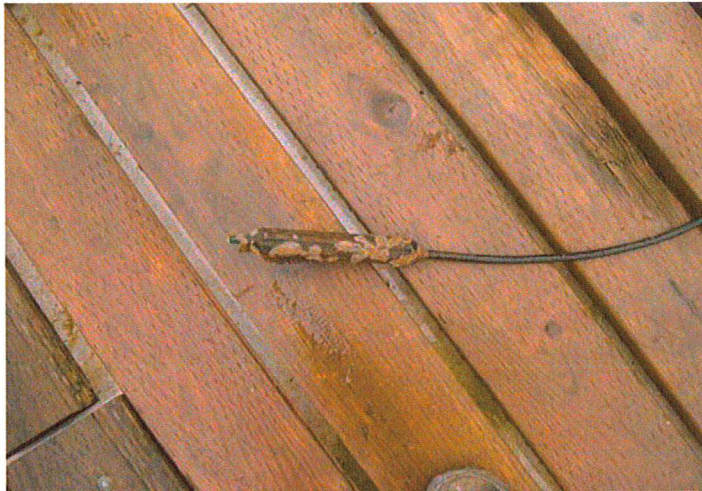
Figure A-4: Typical Damage on PT Anodes

There are a total of 52 rectifiers and 52 anodes installed on this bridge. At the end of the last evaluation in 2004, 15 of the 52 zones were not operational due to missing anodes. The remaining anodes had exhibited signs of accelerated consumption of platinum at the top of the anode and in some cases at the bottom of the anode. The condition of many of the endcaps was not satisfactory. Some had started to deteriorate and water was penetrating inside the caps. In some endcaps the mechanical crimp were extending outside the endcap and water was able to easily penetrate inside it. In general, the quality of the endcaps was considered to be poor considering the environment it is to be used in. Water penetration inside the caps can result in failure of the connection due to corrosion of the copper in the crimps. During this evaluation the condition of the endcaps was similar to the previous evaluation. In fact several more anodes failed since the last inspection due to failure in the endcaps.

PT Anode Broken at the Endcap.

1. Replace all missing and damaged anodes per Tables 3 and 4 of Appendix B within the next 12 months with alternate titanium anode design provided in Appendix E.
2. Correct labeling of anchors FL4-S, FL5-S, and GL3-S of LVM Bridge on the side of the pontoons. Provide missing labels on the north side of the LVM Bridge and pontoons A and R of HH Bridge.
3. Correct labeling of rectifiers of zones FL4-N, FL4-S, FL5-N, FL5-S, F-N, F-S, G-N, G-S, GL3-N, and GL3-S of LVM Bridge
4. Repair broken meter switches on rectifiers of zones H-S and J-N of HH Bridge and zones K-S and P-S of the LVM Bridge.

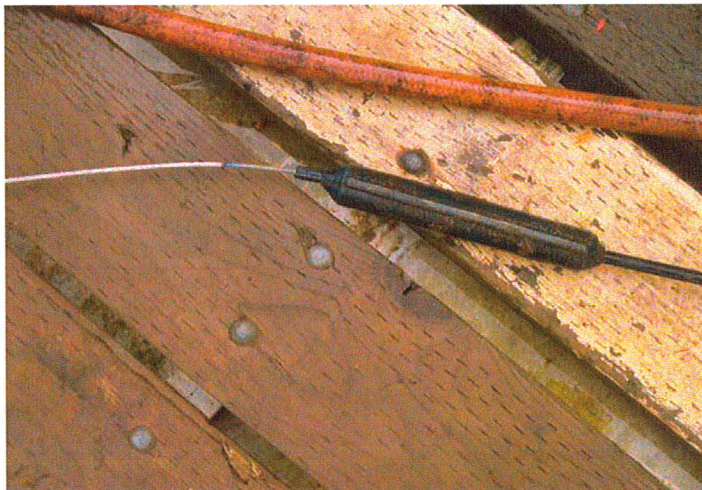
Burn Mark on PT Anode just below the Endcap.

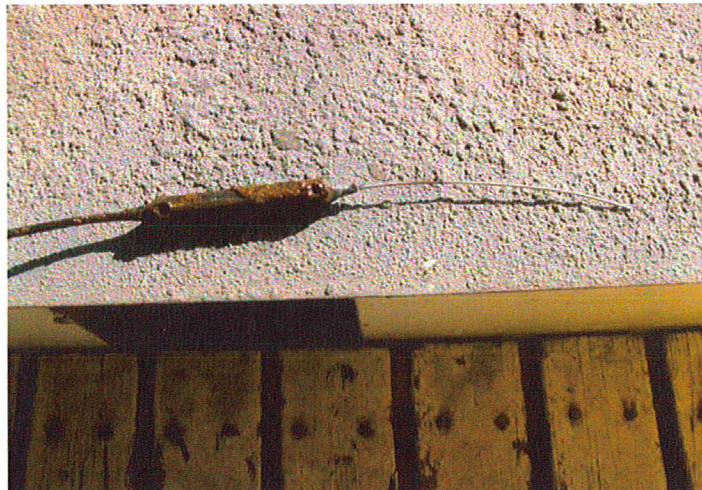
The general condition of the platinum anodes is better than the HH Bridge. One anode was kinked during evaluation and is expected to fail in the near future.

PT anode broken due to kink in the wire.

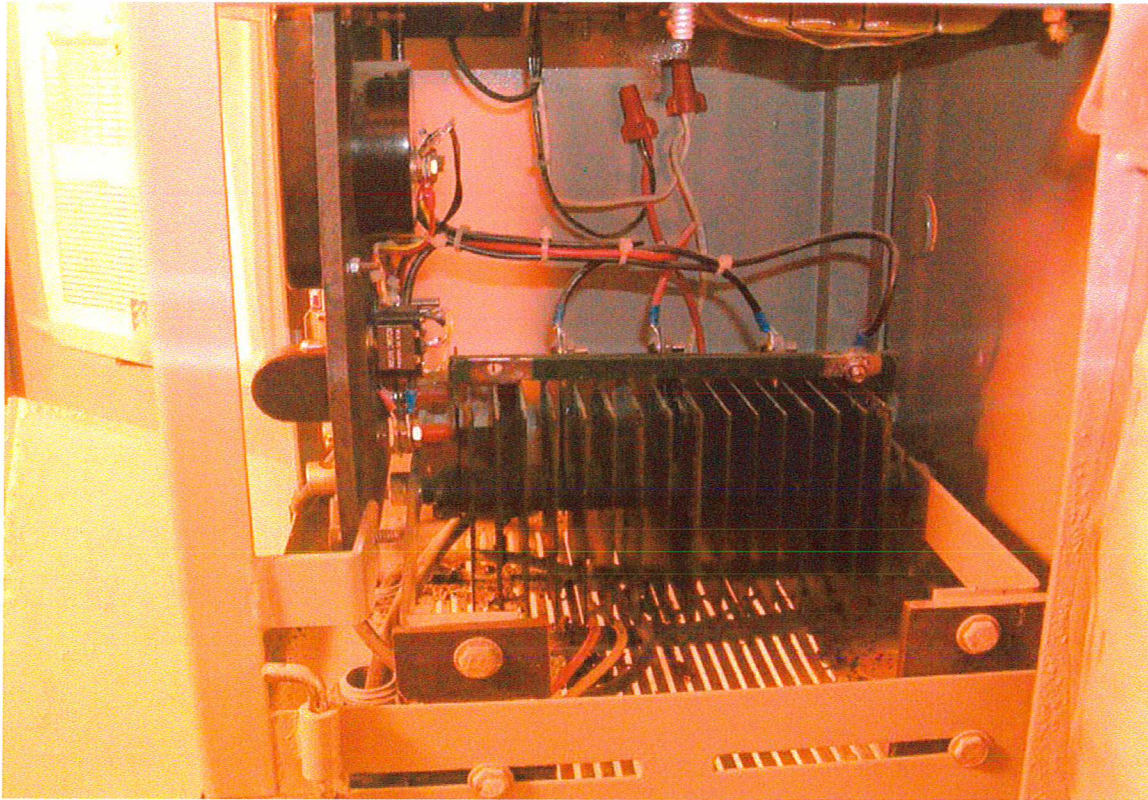
Figure A-5: Typical Silicon Stack

Some rectifiers exhibited signs of aging. Ground and anode wire exhibited wear and tear at the lug connections. A few switches for controlling the installed meters were malfunctioning and need replacement. Sparking in the silicon stack and deterioration of paint on the silicon stacks was observed in some rectifiers (see Figure A-5 in Appendix A). Foul smell emanated from silicon stacks in some of the rectifiers when the rectifiers were reenergized. The foul smell always accompanied sparking in the silicon stacks. In some silicon stacks dead insects were observed between stacks of silicon. It was thought that the foul smell was generated by electrocution of dead insects. However, this was not conclusively verified.

Rectifiers exhibited normal wear and tear. Failed switches, missing bolts that hold the rectifier frame onto the NEMA 3 enclosure, stuck enclosure doors, meters experiencing loss of calibration, faulty breaker, etc. were observed. Silicon stack of one Goodall rectifier failed upon reenergizing and the rectifier was replaced by a spare Universal Rectifier and on another rectifier the breaker was malfunction and the rectifier was replaced. On some rectifier silicon stacks, the paint was peeling off and exhibited signs of deterioration. Sparks were noted on silicon stacks of some rectifiers when they were energized and the sparking was accompanied by a foul smell.

Silicon Stack exhibiting coating deterioration.

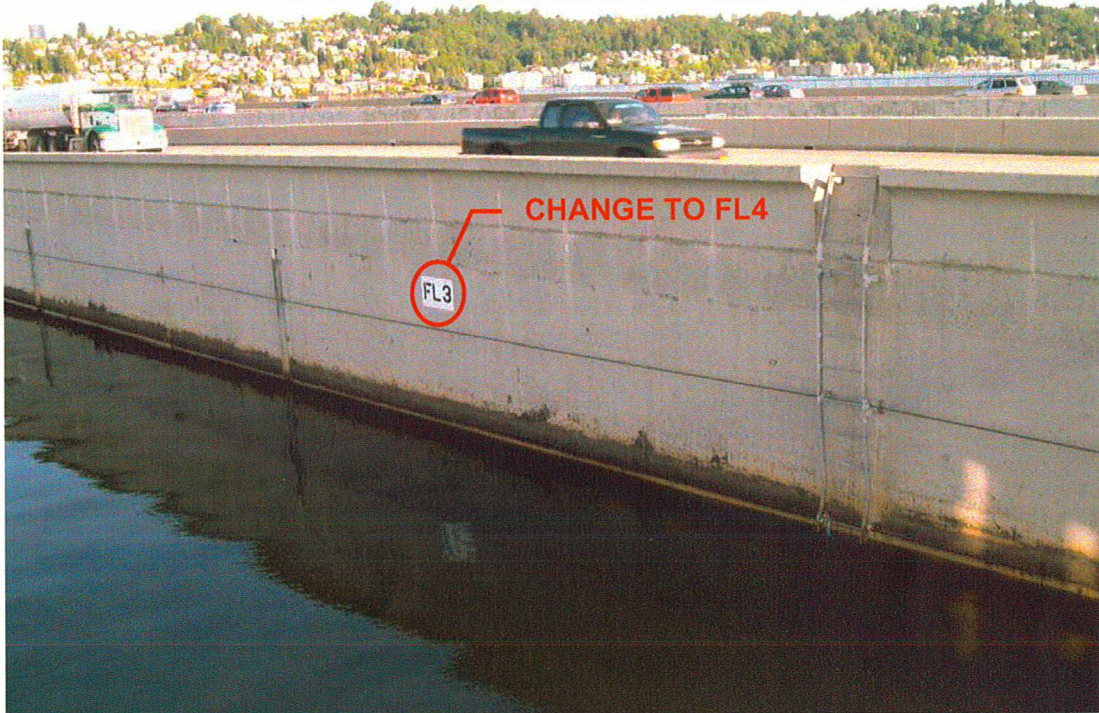
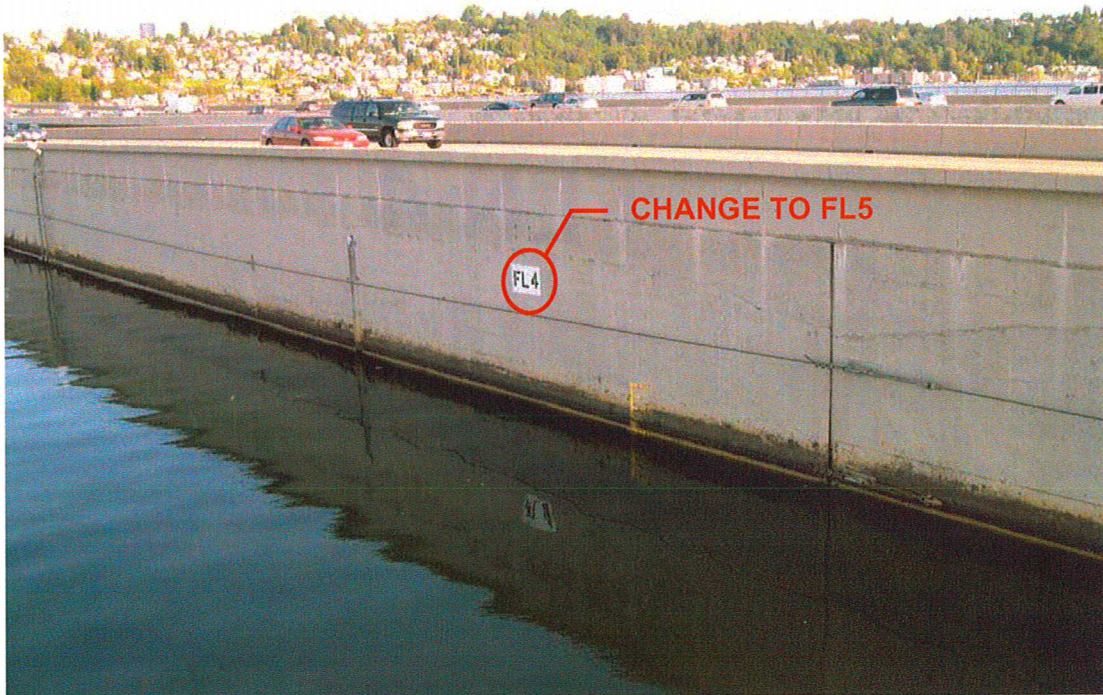
Figure A-6: Correction to Labels on Pontoons

The labels on the south side of the LVM Bridge pontoons F and G incorrectly identify the longitudinal anchor cables. There were no labels at all on the north side of this bridge. Labels are also missing on the north side of pontoons A and R of the HH Bridge. It is recommended that missing labels be provided and the labels on the south side of

**LVM BRIDGE SOUTH SIDE PONTON F**

pontoons FL4-S, FL5-S, and GL3-S of LVM Bridge be corrected. The correct labeling should also be installed on the rectifiers FL4-N, FL4-S, FL5-N, FL5-S, G-N, G-S, GL3-N, and GL3-S of LVM Bridge and the old labels be removed so as to not cause any confusion. The labeling on rectifiers of F-N and F-S should also be corrected.

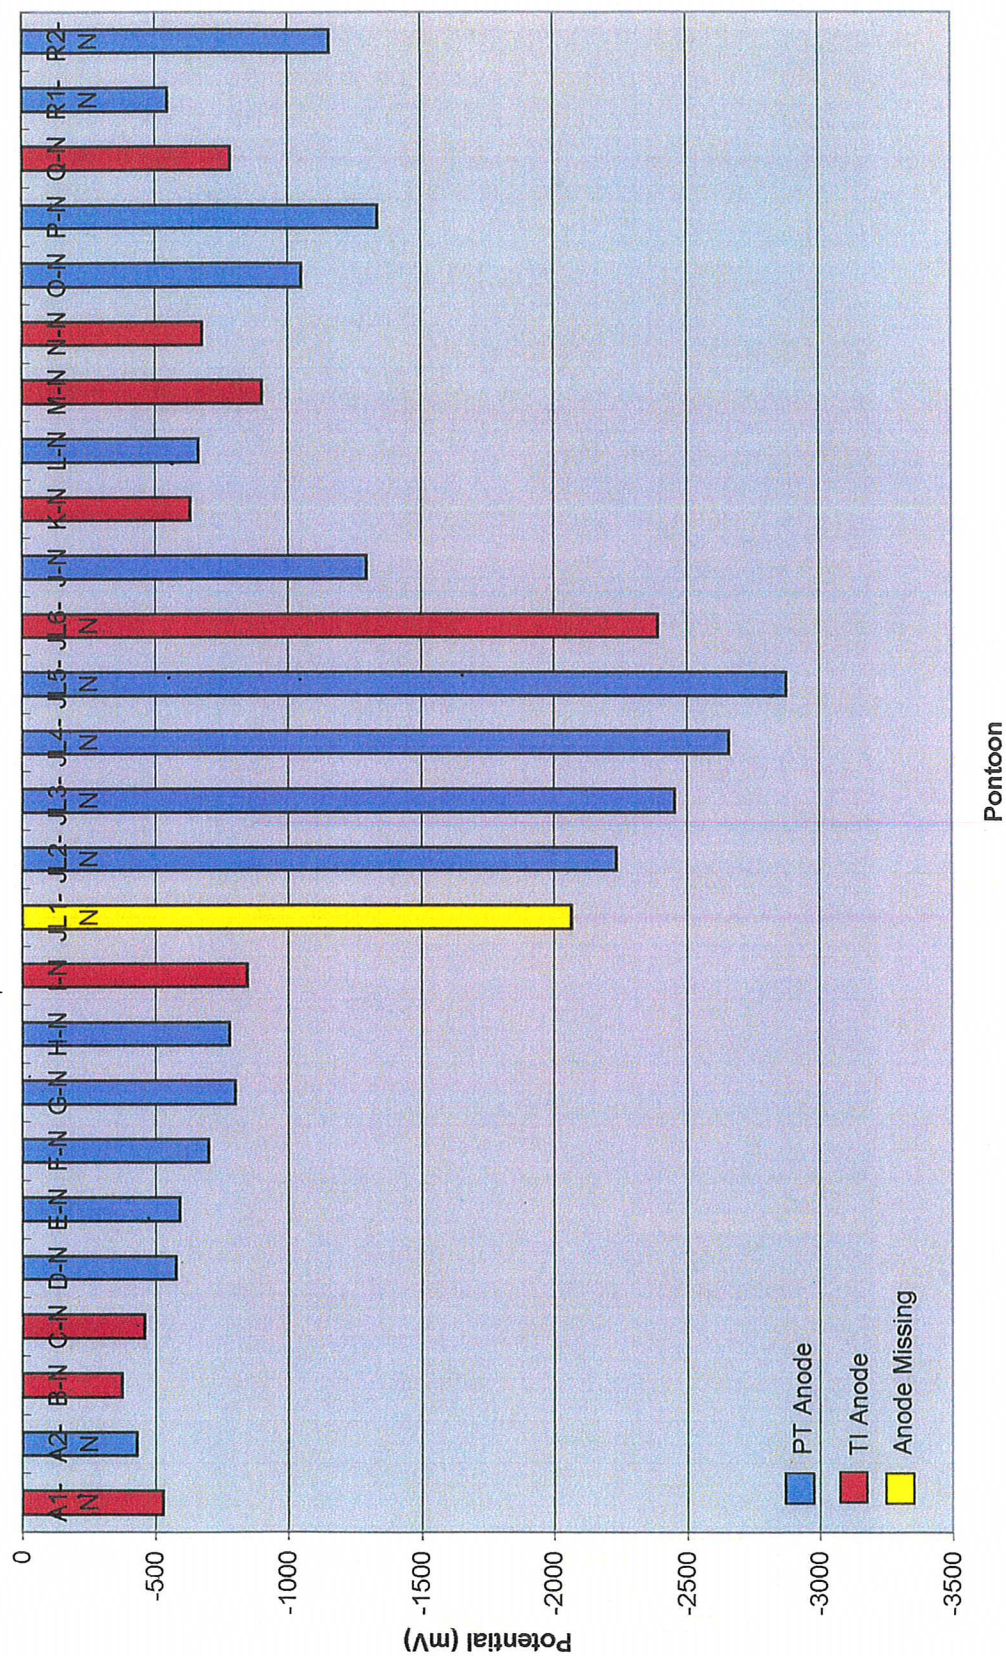
Figure A-7: Instant-Off Potentials of Cable on the North Side of HH

The depolarization for HH Bridge varied from 64 to 4,300 mV with an average of 1,439 mV. As the component of IR drop in each measurement is not know, these depolarizations are not considered to be representative of true depolarizations. However, lower depolarizations on some of the cables is of concern, as with the subtraction of the IR drop the true depolarization in those zones would be lower that what is reflected here. The average static potential of the cables of the HH Bridge was -464 mV.

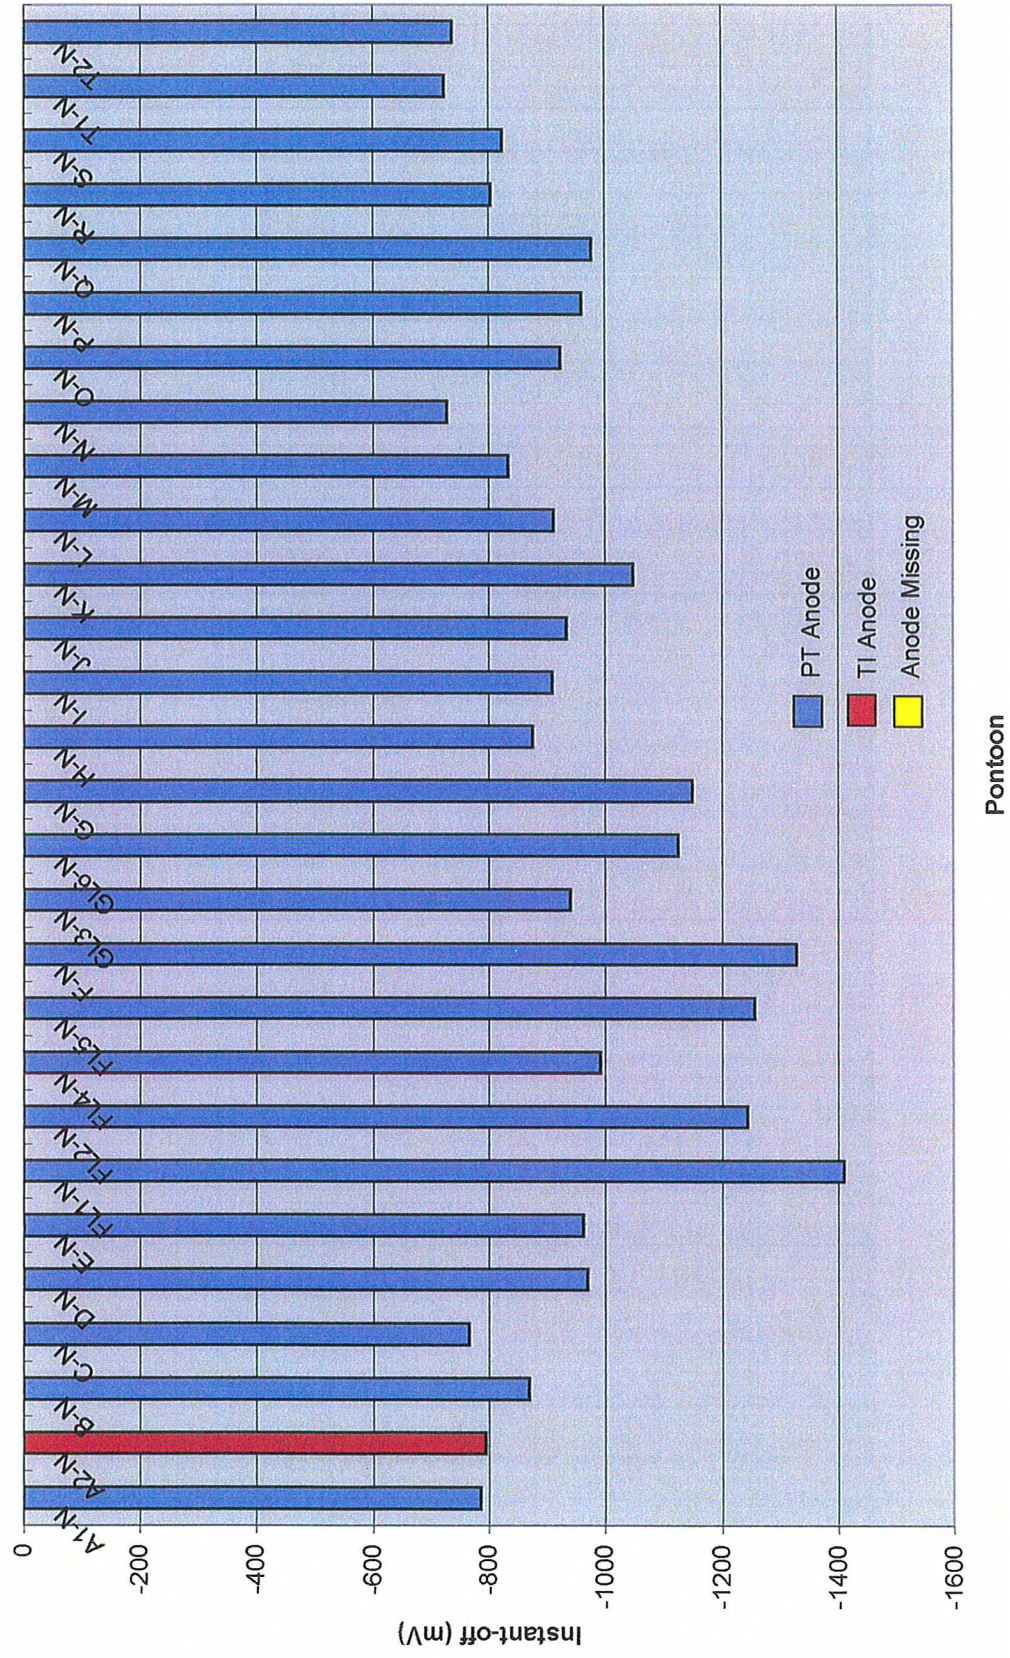
Figure A-9: Instant-off Potentials of Cables on the North Side of LVM

The depolarization for the LVM Bridge varied from 92 to 905 mV with an average of 425 mV and the polarization varied from 39 to 947 mV with an average of 390 mV. The average instant-off potential after re-energization was -1,042 mV and the average static potential was -669 mV. All depolarization/polarization data is presented in Table 2 in Appendix B.
